**Conservation Issues of Sikh Gurudwara Guru Singh Sabha at
Mansehra and its Tourism Potential**

Gurudwara Guru Singh is one of the most sacred heritage sites of Sikhs, denoting their rule in the area. It is a masterpiece of art and architecture along with religious significance. The objectives of this study are to highlight conservation issues of this Gurudwara, its tourism potential and to make it sustainable tourism destination. Data for this study was collected through primary and secondary sources. The study reveals that the Gurudwara has a rich potential of tourism attracting thousands of tourists of diverse motivations being located at a significant route but at the same time is under heavy threats of conservation issues and if proper measures are not taken well in time, it will deteriorate rapidly vanishing a whole chapter of Sikh history of the region.

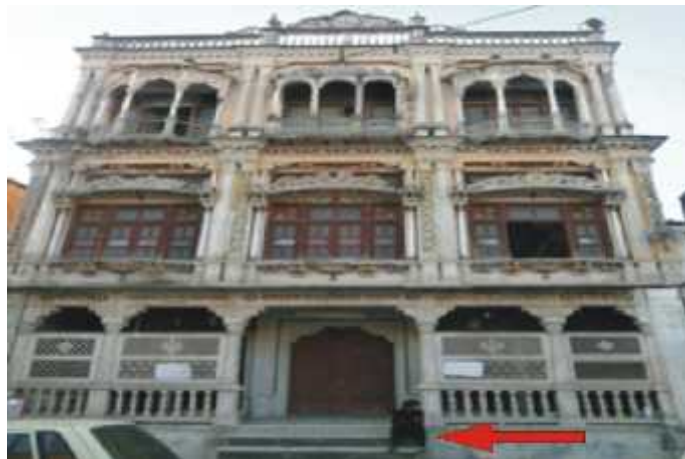
In addition to alteration, the walls of the Gurudwara are also used for posting the pamphlets (for advertisement) by the local community, with the result; the monument is constantly losing its integrity day by day.

Figure 9 - Publicly misuse

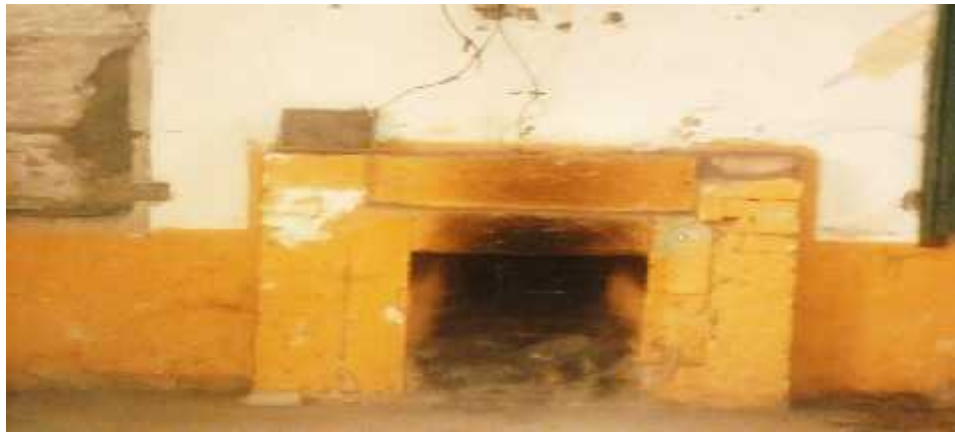
According to the librarian, most of the walls and floor parts are burnt due to smoke and fire in the building. The structural damages and muddled corners are clearly seen. The entire roof of the second floor is seen dark and dusky due to smoke stains.

Figure 10 - Chimney on the second floor

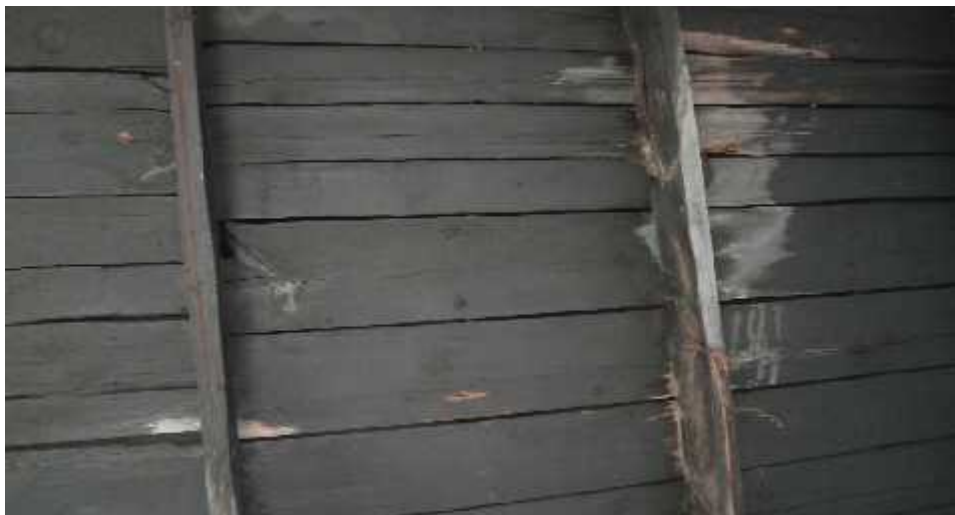
Figure 11 - Smoky black ceiling on second floor

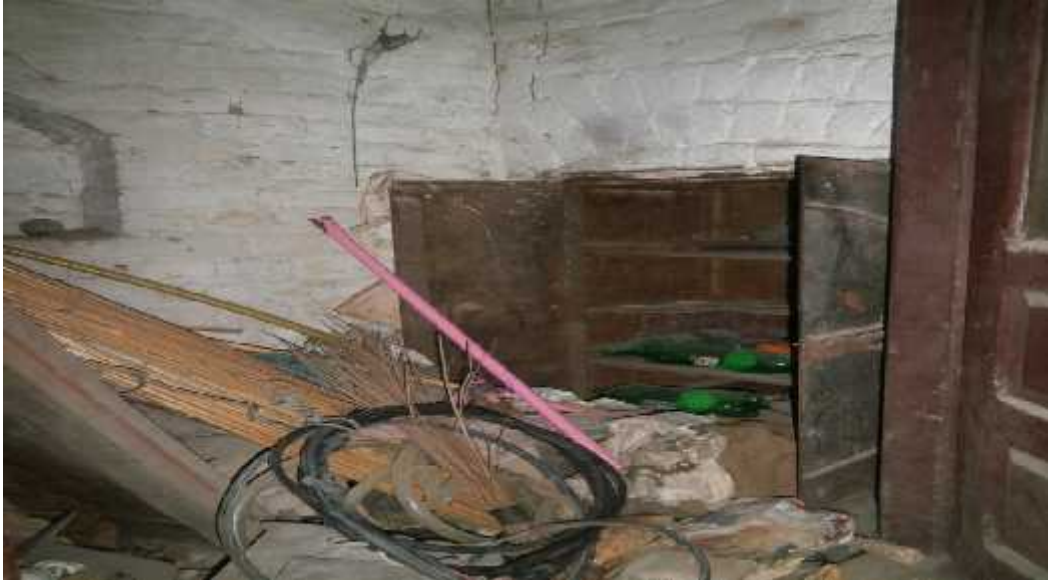
Serious mismanagement has been observed. Electric wires are crossing everywhere in the building across the floor, stairs, and walls as well as on the roof which spoils the appearance of building. It can also cause short circuit that can be dangerous for the building and other material in Gurudwara.

Figure 12 - Waste and garbage on first floor

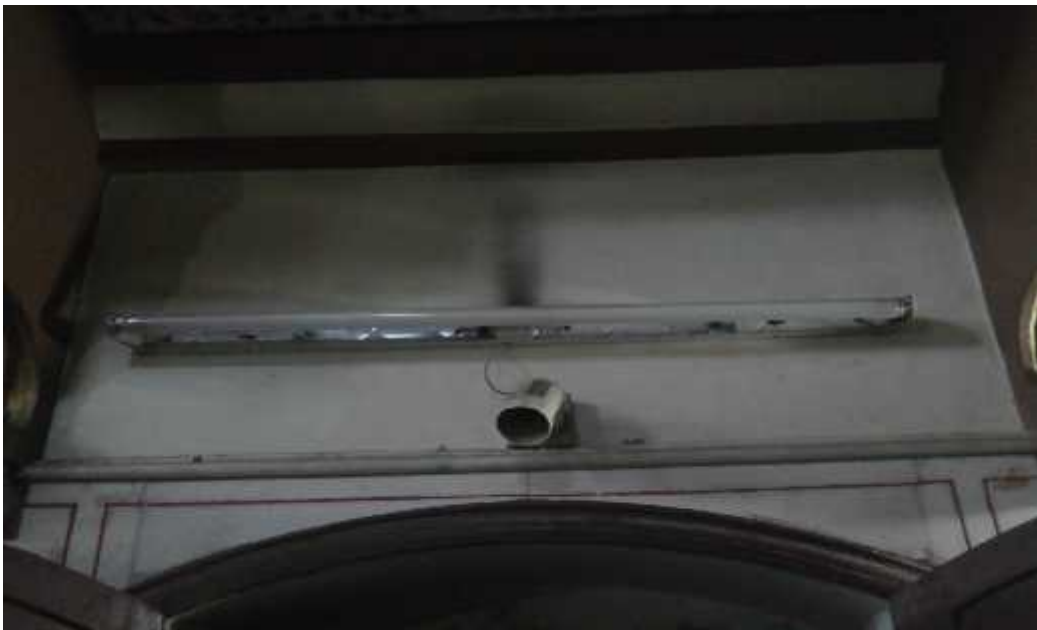
Figure 13 - Black soot caused by the short circuit on the wall of the ground

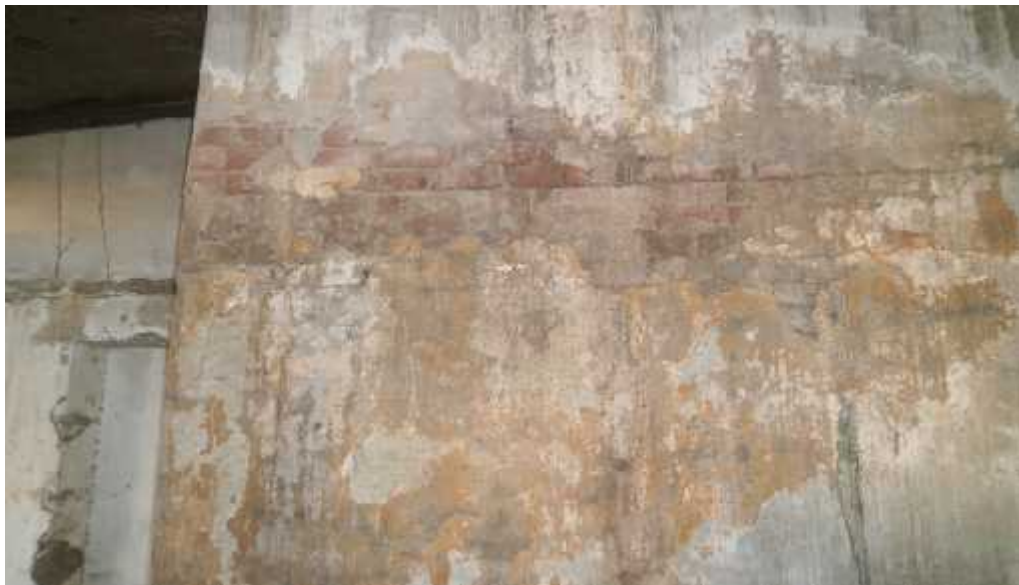
Brick is the major construction material used in the construction of the Gurudwara. While stucco is utilized for inner and outer adornment of the Gurudwara. Bricks can gradually decay through weathering process including sulphurous smoke brought on by dirtied environment. As this Gurudwara is located in main bazaar, is exposed to substantial activities like, water infiltration through little gaps and openings of the block on the second floor; and moistness in divider and second floor was noticed. Because of unsafe vegetation and mould or parasitic development that amasses in the block surface causes block rot on second floor. Blocks dividers are likewise rotting because of breaks brought about by auxiliary developments.

Figure 14 - Brick decay can be seen on second floor

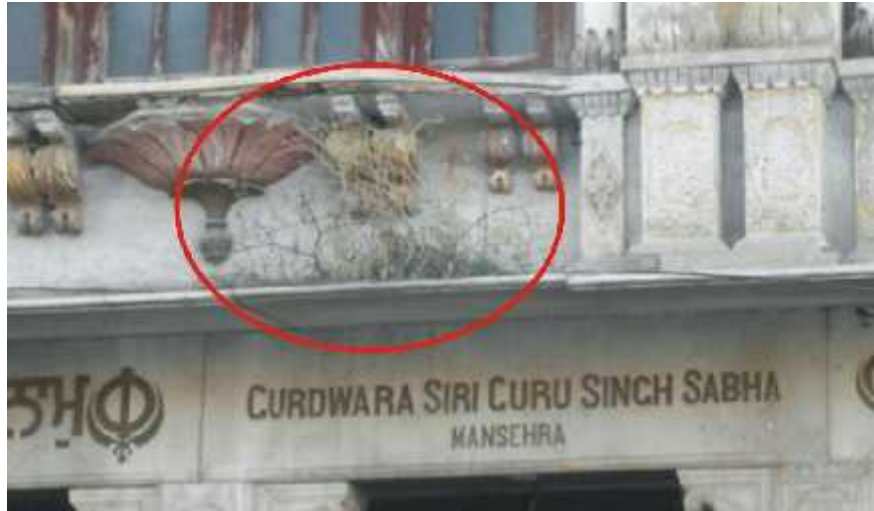
Figure 15 - Wild growth can be seen in the Facade

- Check the leaking of Gurudwara windows and doors
- Check out the pipes which are used in the Gurudwara
- Prevent the wild growth on the shades of the windows of Gurudwara.

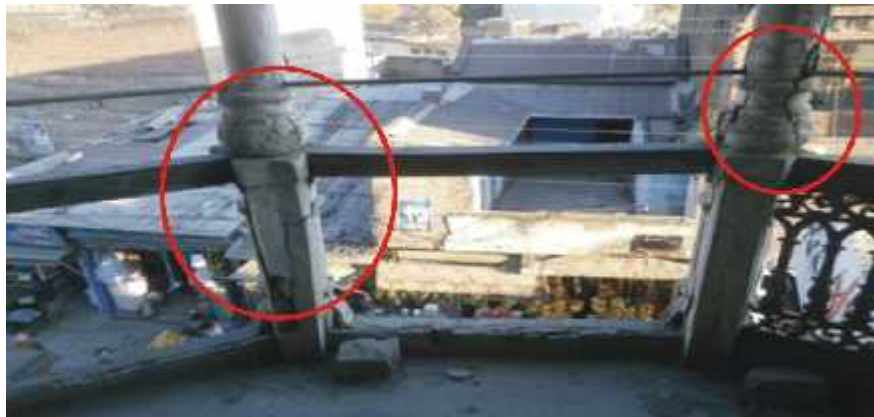
Deep cracks were observed in the Gurudwara by the earthquake of October 8, 2005. The magnitude of this earthquake was 7.6 at Richter scale. Earthquake affects main entrance also because its level of floor is lower than other level of floor of the building. Vibration due to earthquake also caused minor cracks in marble.

Figure 16 - Major cracks can be seen

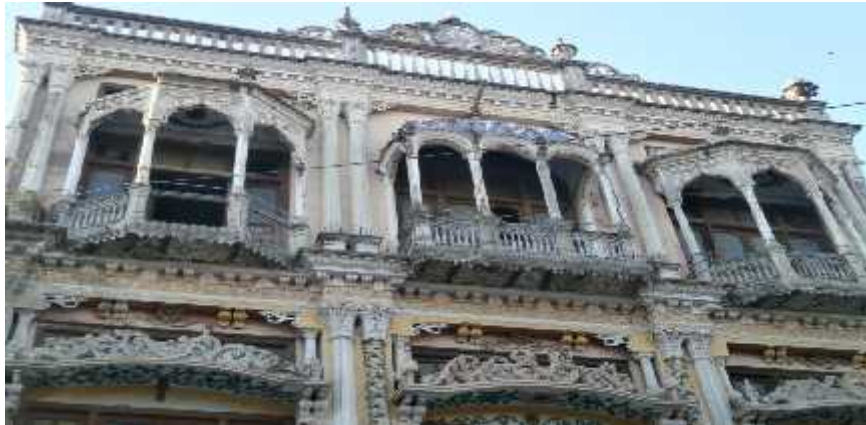
Stucco work can be found on the primary facade and inside the building. Moreover, stucco in facade is consumed to some degree because of the acidic downpour water, sun, and the perilous movement contamination. Erosion occurred to the marble inside façade because of Carbon dioxide, and Tetraethyl Lead¹ mixes depleted from the motors of the vehicles. However, the stuccos inside are for the most part lessened because of the dampness.

Figure 17 - Stucco decay on facade

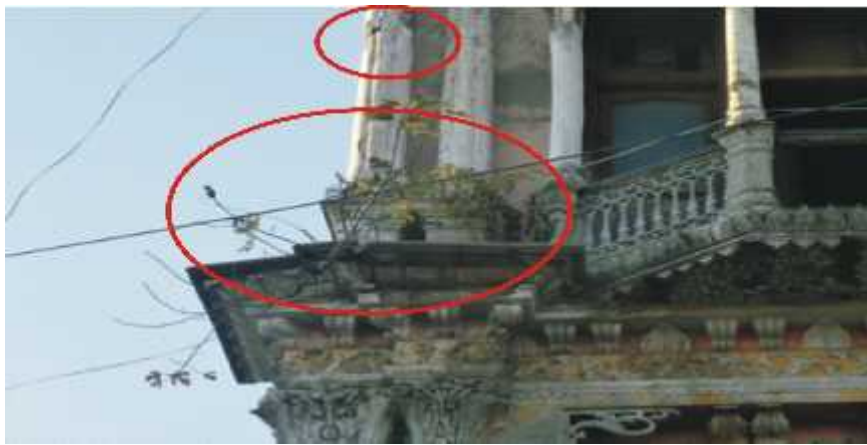
Figure 18 - Cracks and vegetation growth

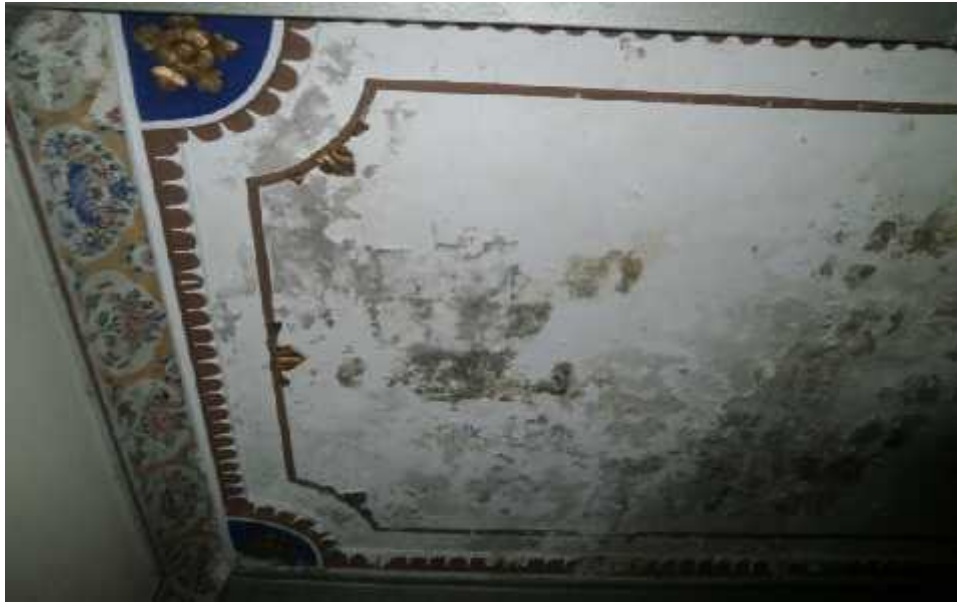
Like timber, stone or block; mortar also has a tendency to fall apart over a timeframe. Mortar contains lime, sand and water; and in some cases, also mixed straw and animals' hairs slashed creature hairs to give rigidity. Here in this building plaster is utilized as a part of roof renderings, cornices, and inner dividers. During the visits it was noticed that clamminess of rooftop and variation in temperature are the major causes of weakening of mortar.

Figure 19 - Plaster decay can be seen

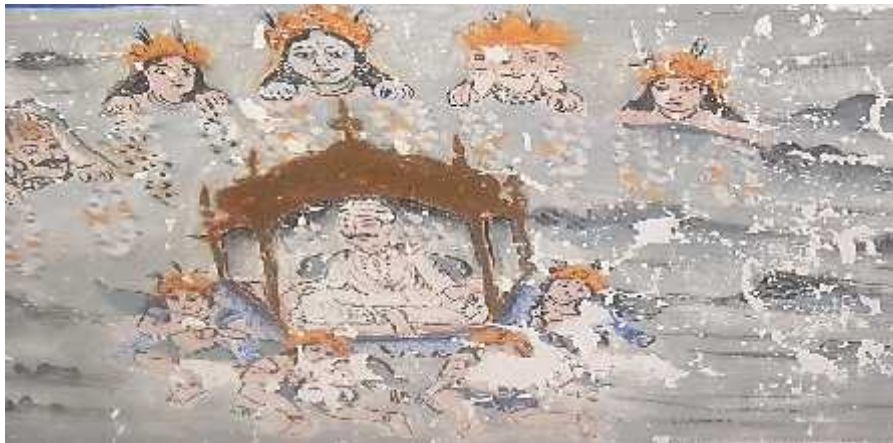
The environment has ended up being an issue for frescoes and different gems. Paintings on Gurudwara roof are badly damaged due to fluctuation in humidity and temperature and dampness. Fresco painting totally faded and not visible. Thus, most of the important frescoes paintings that once adorned the Gurudwara have lost their authenticity. Different adored scenes had been depicted in these painting so their aesthetic values should be preserved by proper reproduction of the disappeared parts and their consolidation.

Figure 20- Decayed painting on the ceiling of Gurudwara on ground floor

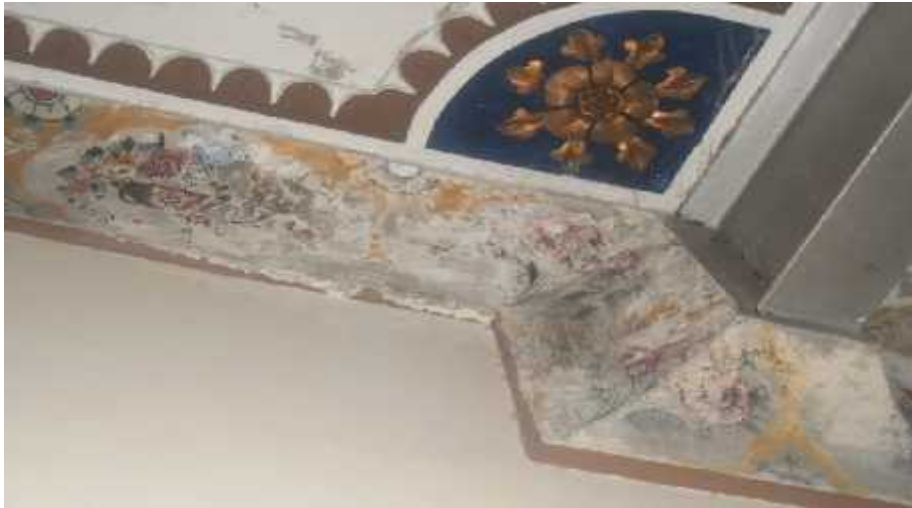
Figure 21 - Decayed painting on the beam of the roof of ground floor

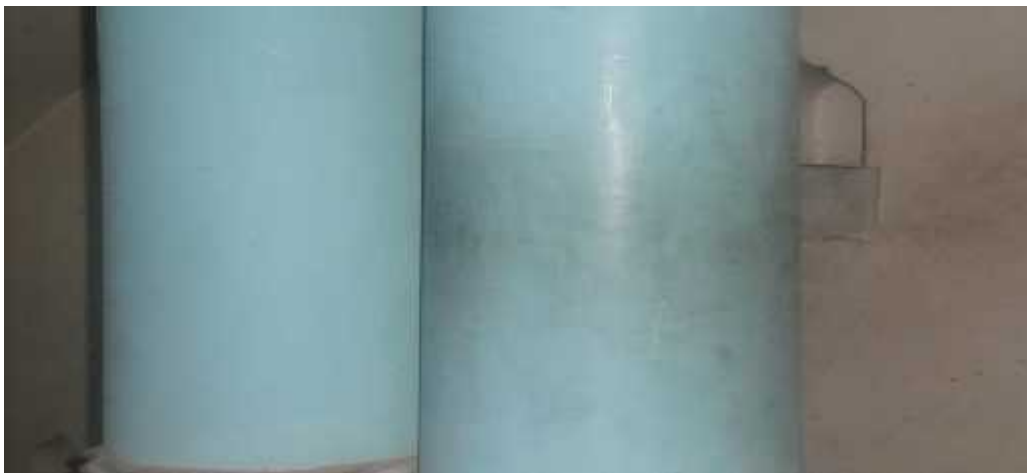
The sculptures and constructions made of marble and limestone have a special position among the unique architectural examples. Many of the famous monuments are intensively decaying under the influence of the natural and anthropogenic factors such as atmospheric humidity and temperature changes, air pollution, salts, aggressive microbial communities. Various types of monuments damages were identified: surface erosion and forming of thick black crusts, the presence of biological films, stone detachment, micro crust, alveolar weathering, and others. Due to variation of temperature and sulphur di oxide gas present in the polluted environment (heavy traffic) cause black stains on the surface of the paintings, walls, pillars and due to oily hands of visitors of the building. Black crust on the walls due to biological growth can be observed on second floor.

Figure 22 - Black stains on the pillars

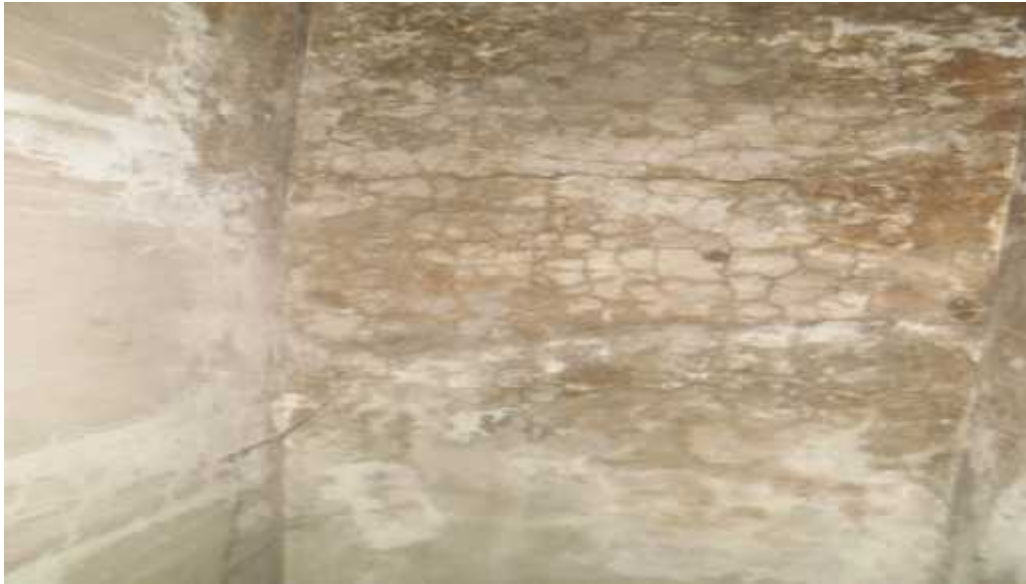
Figure 23 - Stains due to leakage on the ceiling of second floor

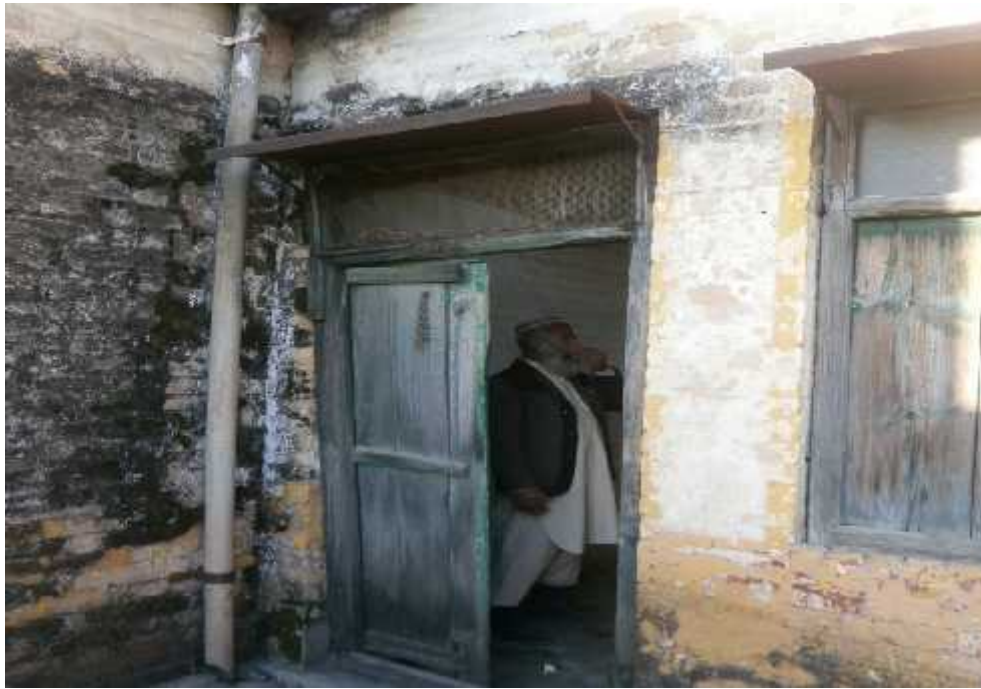
Figure 24 - Black crust on the wall of second floor

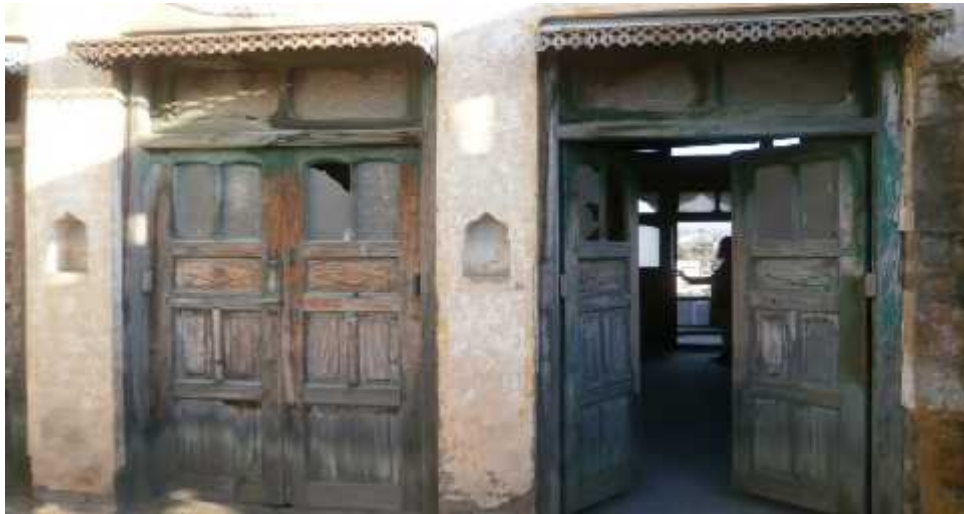
Wood is one of the ancient construction materials used in the historic building of various civilizations. Wood is known to be a very suitable material for the walls and frames of buildings. The Gurudwara is ornamented with alluring wooden work. Bug or termite assaults were noticed in Gurudwara due to sodden

Figure 25 - Wood Decay can be seen on ground floor

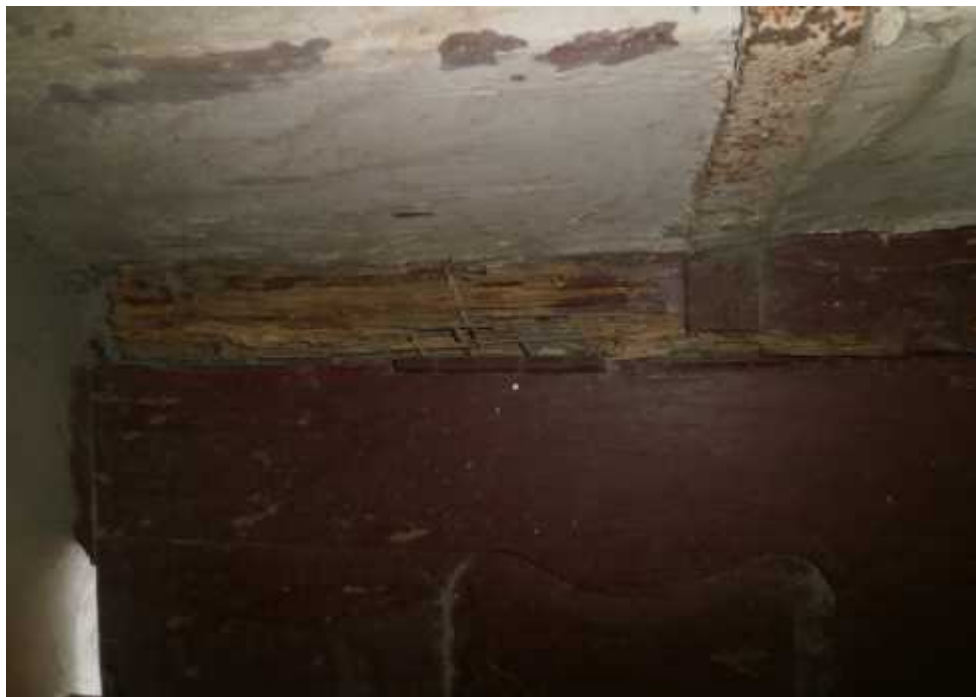
and absorbable timber and in all timbers, which are put against or incorporated with moist walling. Unfortunately, due to careless attitude of the management, wood is constantly decaying because of improper humidity and temperature specifically the windows and doors and wood cupboards are badly damaged and decayed due to termite's attack. Direct sunlight causes fading of colours of wooden doors and surfaces as well.

Figure 26 - Termites attack on door of ground floor

- Insect's traps should be installed
- Dehumidifiers to control the RH and the growth of microorganism should be used
- Day to day maintenance of Gurudwara should be ensured
- Periodic survey for pest in the Gurudwara should be ensured
- Avoid mixing newly books with already displayed till its confirmation that no pest is present.

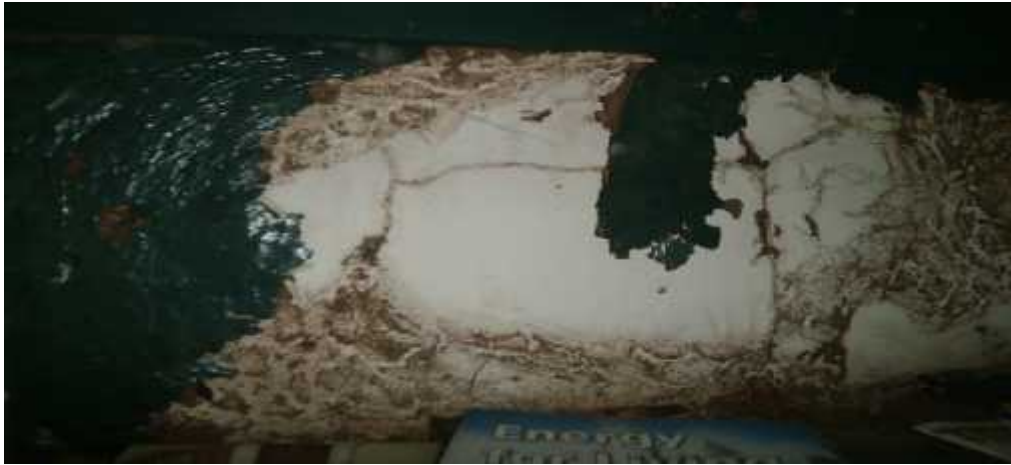
Figure 27 - Termite attack in bookshelves
